HUNTINGTON MEDICAL RESEARCH INSTITUTES  
NEUROLOGICAL RESEARCH LABORATORY  
734 Fairmount Avenue  
Pasadena, California 91105

Contract No. NO-NS-82388  
QUARTERLY PROGRESS REPORT  
April 1 - June 30, 1999

Report No. 6

"SAFE AND EFFECTIVE STIMULATION OF NEURAL TISSUE"

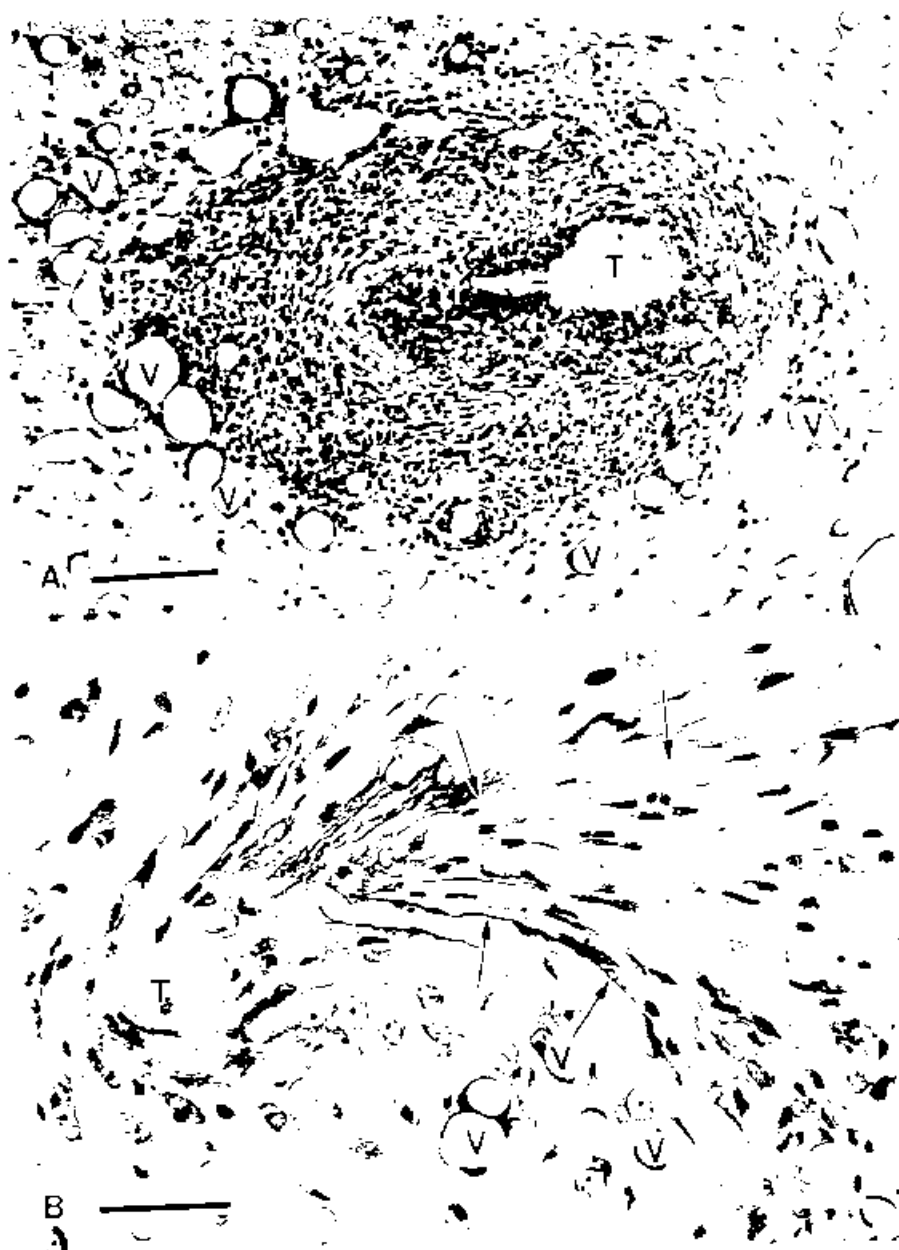
**Fig. 2. A.** Animal IC-181. Electrode track #142. Masterbond bail and Masterbond coated iridium shaft, left postcruciate gyrus. Depth = 400  $\mu$ m. The track (T) is surrounded asymmetrically by numerous glial cells and lymphocytes. A slight tear communicates with the lumen of the track. This probably occurred during electrode removal. Vascular hyperplasia is prominent (V). At greater magnification, the neurons appeared normal; however, the closest neurons were 50  $\mu$ m or more from the track. As in Fig. 1, the sheath is not present. Nissl stain. Bar = 100  $\mu$ m.

**B.** Tip (T) of track shown in A above. A directional scar. The comet-like appearance of the track with "streaming" connective tissue indicates movement of the electrode during or after insertion. Several glial cells are incorporated into the partially formed connective tissue scar (delimited by the arrows). Vascular hyperplasia (V) is present. Nissl stain. Bar = 50  $\mu$ m.

1. Masterbond Ball and Uncoated Iridium Shaft. Along one of the three electrodes, neurons appeared ill-defined and "smudgy." This track was also accompanied by gliosis ranging from zero to +++ (Fig. 1A&B; see Table 1 for quantitative criteria). The remaining two tracks showed normal neurons no greater than + gliosis. One of the electrodes was accompanied by a linear scar which we presume is due to electrode movement.
2. Masterbond Ball and Masterbonded-Coated Ir Shaft. Four individual electrodes were inserted into the left postcruciate gyrus. Aside from occasional flat neurons near one of the electrodes, all neurons appeared normal. Linear scars accompanied two tracks, indicating electrode movement. At various depths below the pia, gliosis was rare along one electrode track, ranged from zero to ++ near two others and from + to +++ at the remaining track (Fig. 2A&B).

(one month after implantation) in the gliotic sites adjacent to electrode tracks. This indicates an ongoing toxic reaction (compare the thin sheath of Fig. 5B with Figs. 1, 2, 3, 4, 5A and 6). We consider this toxicity to be a serious problem and have suspended our cortical microstimulation protocols to resolve the etiology. In future experiments we will sonicate the electrode arrays in alcohol after unpackaging in the surgical suite, followed by an alcohol flush just prior to implantation. We will also further investigate each step of the fabrication procedures. We will also use a clean room for the final stages of fabrication and, finally, our surgical suite is being equipped with a pre-filter, hepa filter at the air intake and a 4" fan at the return vent.

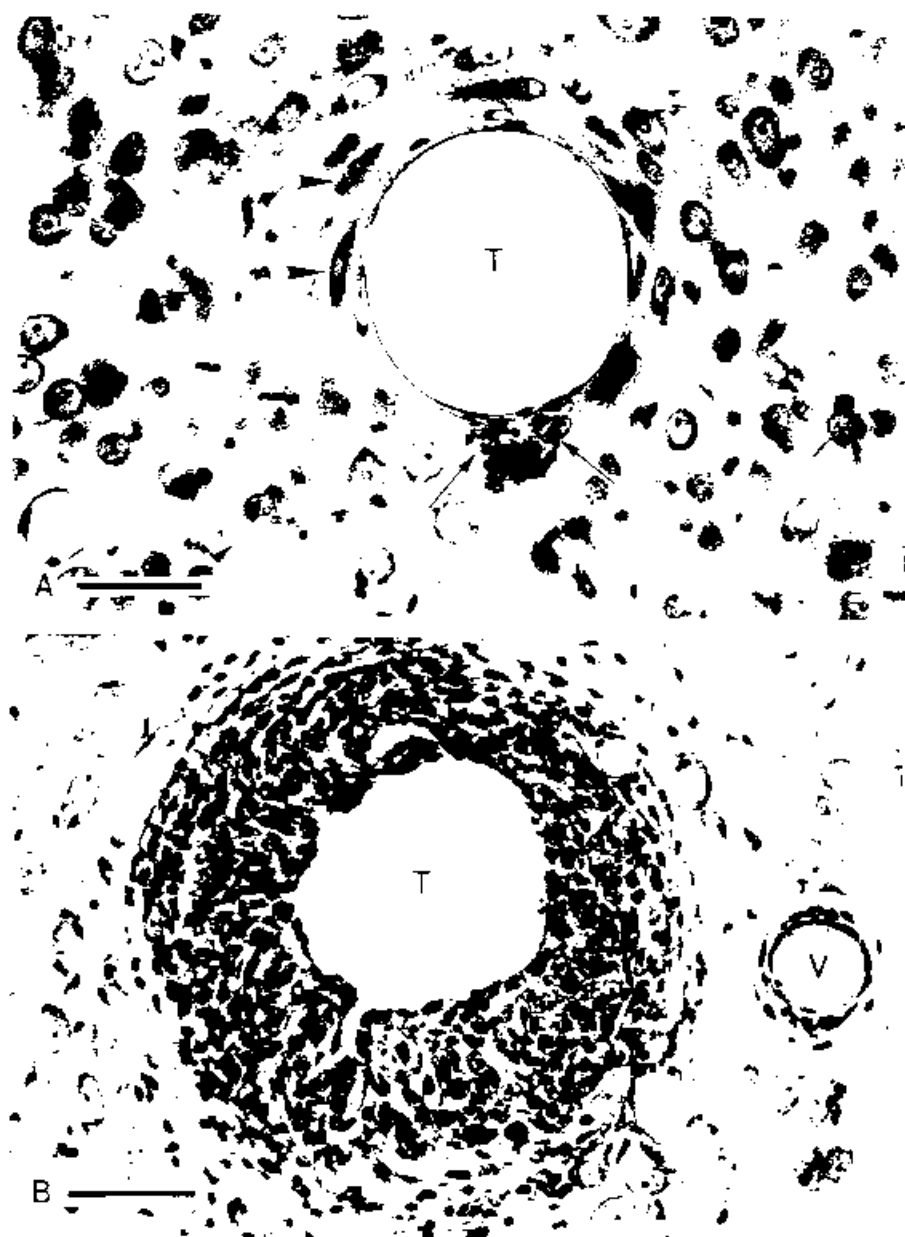
**Fig. 3. A.** Animal IC-187. Uncoated iridium stabilizer track (#10), posterior array left gyrus suprasylvius. Depth = 305  $\mu\text{m}$ . Aside from a small focus of glial cells (arrows), the track (T) is skirted by a markedly thin sheath. A few neurons (arrow heads) near the track are flattened although the remaining neurons in the field appear normal. Nissl stain. Bar = 50  $\mu\text{m}$ .

**B.** Same track as in A above at a depth of 500  $\mu\text{m}$ . Several layers of glial cells symmetrically surround the track (T). One nearby blood vessel (V) is cuffed with lymphocytes. Nearby neurons appear normal. Nissl stain. Bar = 50  $\mu\text{m}$ . All subsequent micrographs are also from Animal IC-187.

1. Uncoated Ir Stabilizer Tracks. For the most part, neurons along both tracks appeared normal but occasional flat neurons frequently were found. Both tracks were accompanied by a rounded scar, and one of these also contained a linear scar, signifying electrode movement as well as a hemorrhagic etiology. Both tracks were accompanied by a wide range of gliosis ranging from none, highly localized (Fig. 3A) to +++, and completely surrounding the track (Fig. 3B).

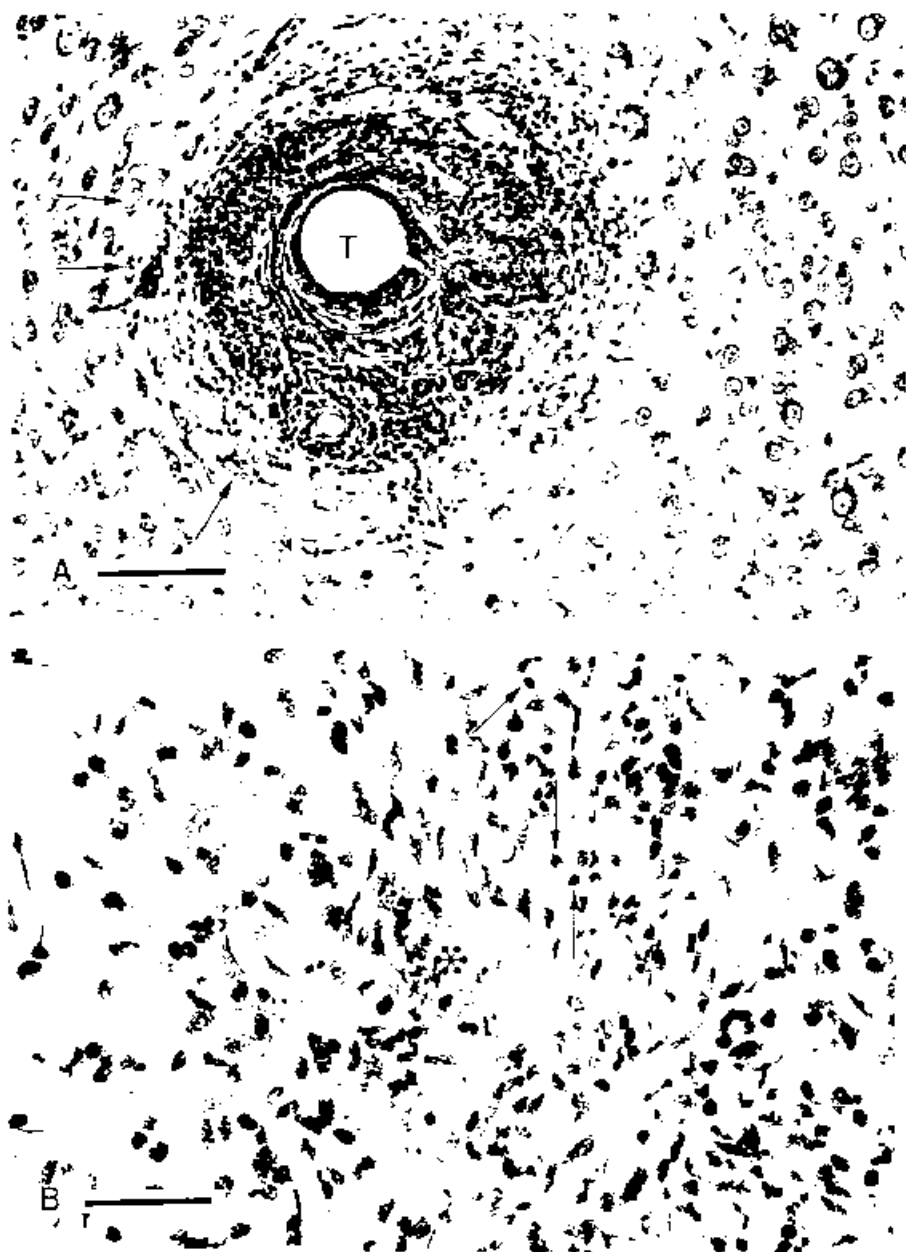
Fig. 6. A. Track #14 (Parylene) in posterior array. Depth = 300  $\mu$ m. Numerous lymphocytes (small, dark round cells) surround the glial aggregate around the track (T). Aside from a few flattened neurons (arrows), most neurons appear normal. Nissl stain. Bar = 100  $\mu$ m. B. Tip site (asterisk) of same track #14 as shown in A above. Numerous, loosely dispersed astrocytes (arrows) are scattered near the tip. The neuropil appears normal. H&E stain. Bar = 50  $\mu$ m.

4. Parylene Coated Shafts. Three of four tracks were accompanied by well-developed, rounded fibroglial scars, probably of hemorrhagic etiology. The remaining track showed no scar. Along one track, gliosis was mild (0 to +), moderate at one track (+ to ++) and marked along the two remaining tracks (+ to +++) (Fig. 6A&B).
